AVIATION INVESTIGATION REPORT

A05Q0024

LANDING BESIDE THE RUNWAY

HAWKER SIDDELEY HS 125-600A N21SA

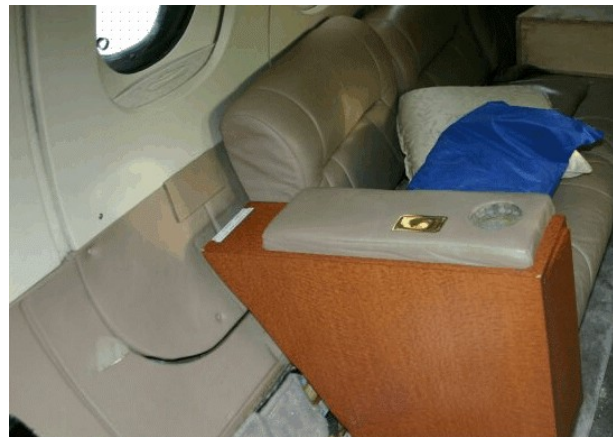
Photo 1. Armrest/cabinet

A cabinet that served as an armrest for the side seat was partially blocking the emergency exit (see Photo 1). The armrest/cabinet is connected to the seat by means of a rail along which it slides when it is necessary to remove it. According to Supplementary Type Certificate (STC) SA4147SW, a notice indicating that the armrest must be removed before each take-off and landing must be displayed when the armrest is in position. At the time of the accident, the armrest/cabinet was in position, and the notice stated that the cabinet should be pulled forward in order for the emergency exit to be used.

The emergency exit could not be opened due to structural damage, which delayed the evacuation and could have had serious consequences. As well, the armrest next to the side seat was blocking the access to the emergency exit. The notice on the armrest was not compliant with the STC, which required that the armrest be removed before each take-off and landing. STCs are not normally provided to pilots, so the flight crew had no way of knowing about this requirement.

1. Because they had not been given a safety briefing, the passengers were not familiar with the use of the main door or the emergency exit, which could have delayed the evacuation, with serious consequences.
2. The armrest of the side seat had not been removed as required and was blocking access to the emergency exit, which could have delayed the evacuation, with serious consequences.
3. Because they had not been given a safety briefing, the passengers seated in the side seats did not know that they should have worn shoulder straps and did not wear them, so they were not properly protected.
4. The possibility of flying to an airport that does not meet the standards for night use gives pilots the opportunity to attempt to land there, which in itself increases the risk of an accident.

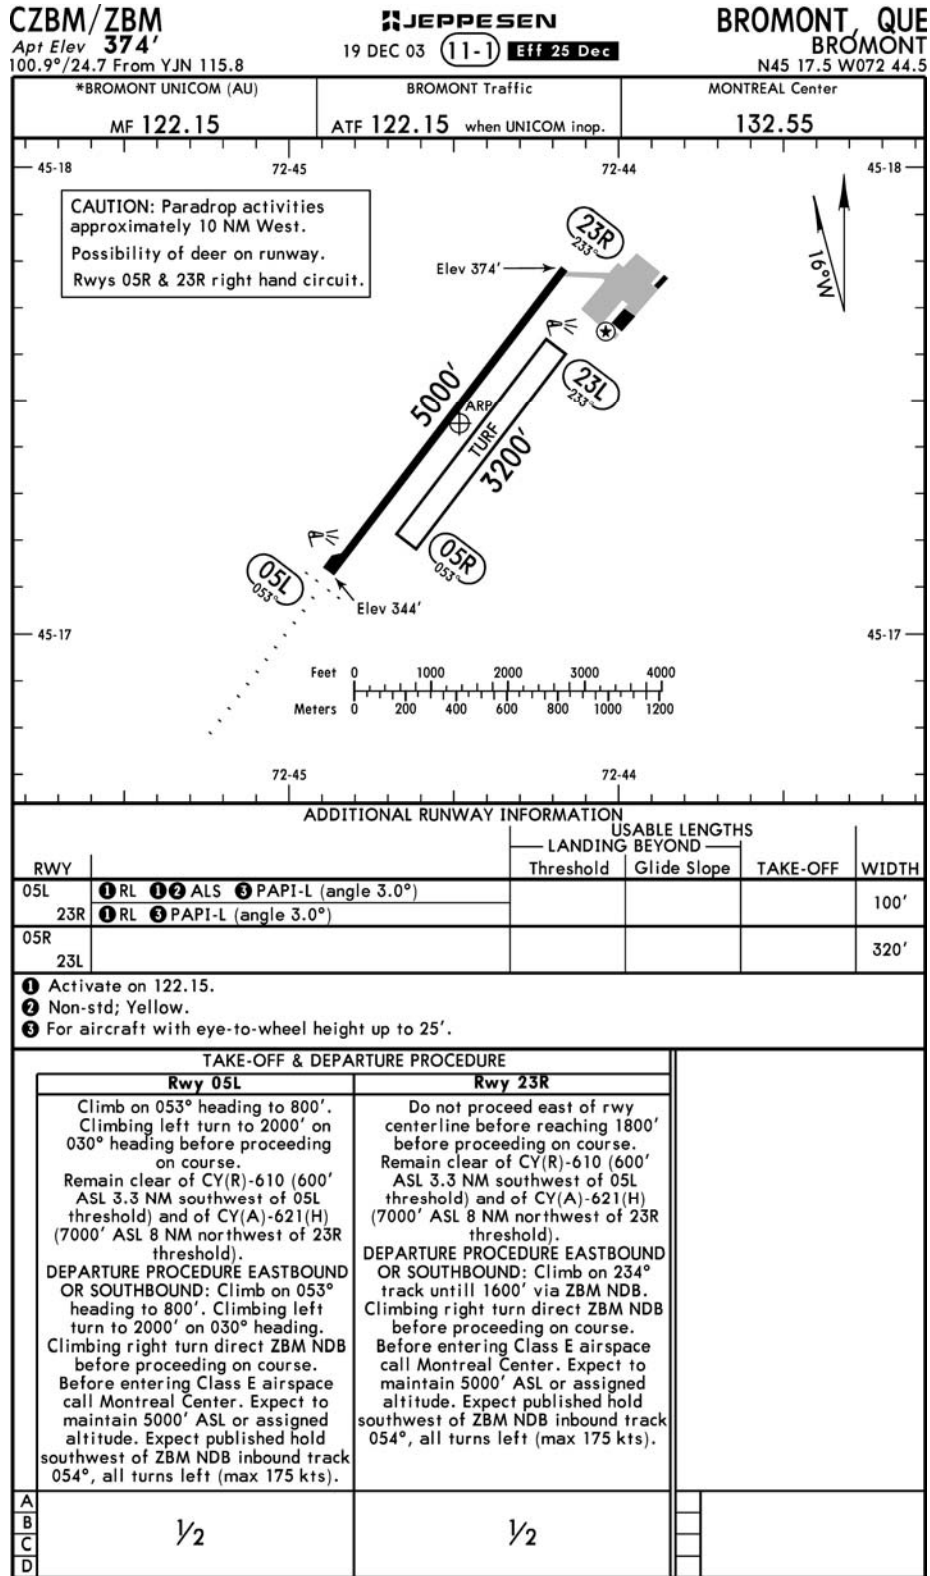
Appendix A – Aerodrome Map

At approximately 1000 feet asl and five miles from the threshold, the flight crew had the approach lights and the PAPI in sight. It was not evident whether the PAPI was positioned on the right or the left side of the runway. The airport chart published by Jeppesen indicated "PAPI-L" (see Appendix A), and interpretation meant that the PAPI was on the left. In response to a query from the crew, the Bromont dispatcher indicated that the PAPI was on the right side of the runway. From his location facing the aircraft, the PAPI was to the dispatcher's right. The approach chart, also published by Jeppesen, showed the position of the PAPI by means of a pictograph, showing a drawing of the runway threshold and the approach lights with the word "PAPI" on the left side of the drawing (see Appendix B). Although that chart was referred to during the approach, there is no indication that the crew noticed the pictograph.
